Tucannon River Programmatic Habitat Annual Report

Project #: 2010-077-00

Annual Progress Report

(Reporting Period January 2017 to December 2017)

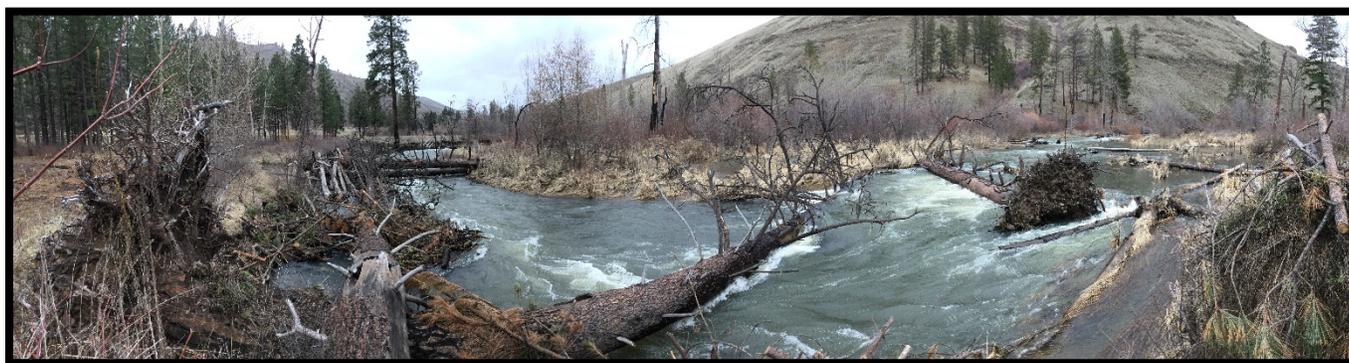
Floodplain connectivity created in a previously incised reach of the Tucannon River in PA-14, during an estimated 450cfs flow.
