20-1055, Plan, Asotin Co Conservation Dist Cougar Creek Fish Passage Design, RCO Grant Request: \$80,000

The Asotin County Conservation District is sponsoring a grant proposal to seek SRFB funds develop a design for the replacement of the existing Cougar Creek culvert, which is a partial to fish passage barrier where Cougar Creek flows under the Grande Ronde River Road. The barrier poses an imminent threat to anadromous fish (Steelhead) and limits their access approximately 2.25 miles of rearing and spawning habitat upstream of the culvert. As stated in the Snake River Salmon Recovery Plan, Steelhead are especially effective at accessing and utilizing stream reaches with suitable habitat, however, their distribution is limited environmental issues such as migration barriers. Cougar Creek flows directly into by the Grande Ronde River approximately 140 feet below the barrier. The current culvert was identified in 2010 by the Walla Walla Community College Road Crossing Barrier Assessment as a barrier.

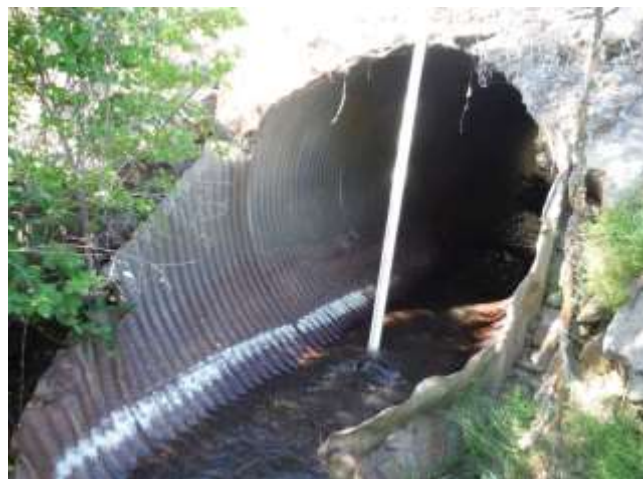
Level A Culvert Assessment Report

Culvert Details						Level A Parameters						
<u>ID</u>	<u>Shape</u>	<u>Material</u>	<u>Span</u>	<u>Rise</u>	<u>Length</u>	<u>WDIC</u>	<u>Apron</u>	<u>WSDrop</u>	<u>Location</u>	<u>Countersunk</u>	<u>Backwater</u>	<u>Slope (%)</u>
1.1	RND	CST	1.79	1.88	14.00	0.08	NO	0.27	Outlet	No	No	3.07

Comments
Slope and W.S. Drop barrier. Culvert is damaged at the outlet.

Assessment Results			
Barrier:	<input type="text" value="Yes"/>	Passability (%):	<input type="text" value="33"/>
Reason:	<input type="text" value="Slope"/>	Fishway Present:	<input type="text" value="No"/>
Method:	<input type="text" value="Level A"/>		
Recheck:	<input type="text"/>
