20-1055, Plan, Asotin Co Conservation Dist Cougar Creek Fish Passage Design, RCO Grant Request: \$80,000

The Asotin County Conservation District is sponsoring a design proposal to seek SRFB funds develop construction ready final design for the replacement of the existing Cougar Creek culvert, which is a partial to fish passage barrier where Cougar Creek flows under the Grande Ronde River Road in Southeast Washington. The barrier poses an imminent threat to anadromous fish (Steelhead) and limits their access approximately 2.25 miles of rearing and spawning habitat upstream of the culvert. As stated in the Snake River Salmon Recovery Plan, Steelhead are especially effective at accessing and utilizing stream reaches with suitable habitat, however, their distribution is limited environmental issues such as migration barriers. Cougar Creek flows directly into by the Grande Ronde River approximately 140 feet below the barrier. The current culvert was identified in 2010 by the Walla Walla Community College Road Crossing Barrier Assessment as a barrier. The goal of this project is to develop designs to replace existing culvert.

PROJECT: 20-1055 P, Cougar Creek Fish Passage Design

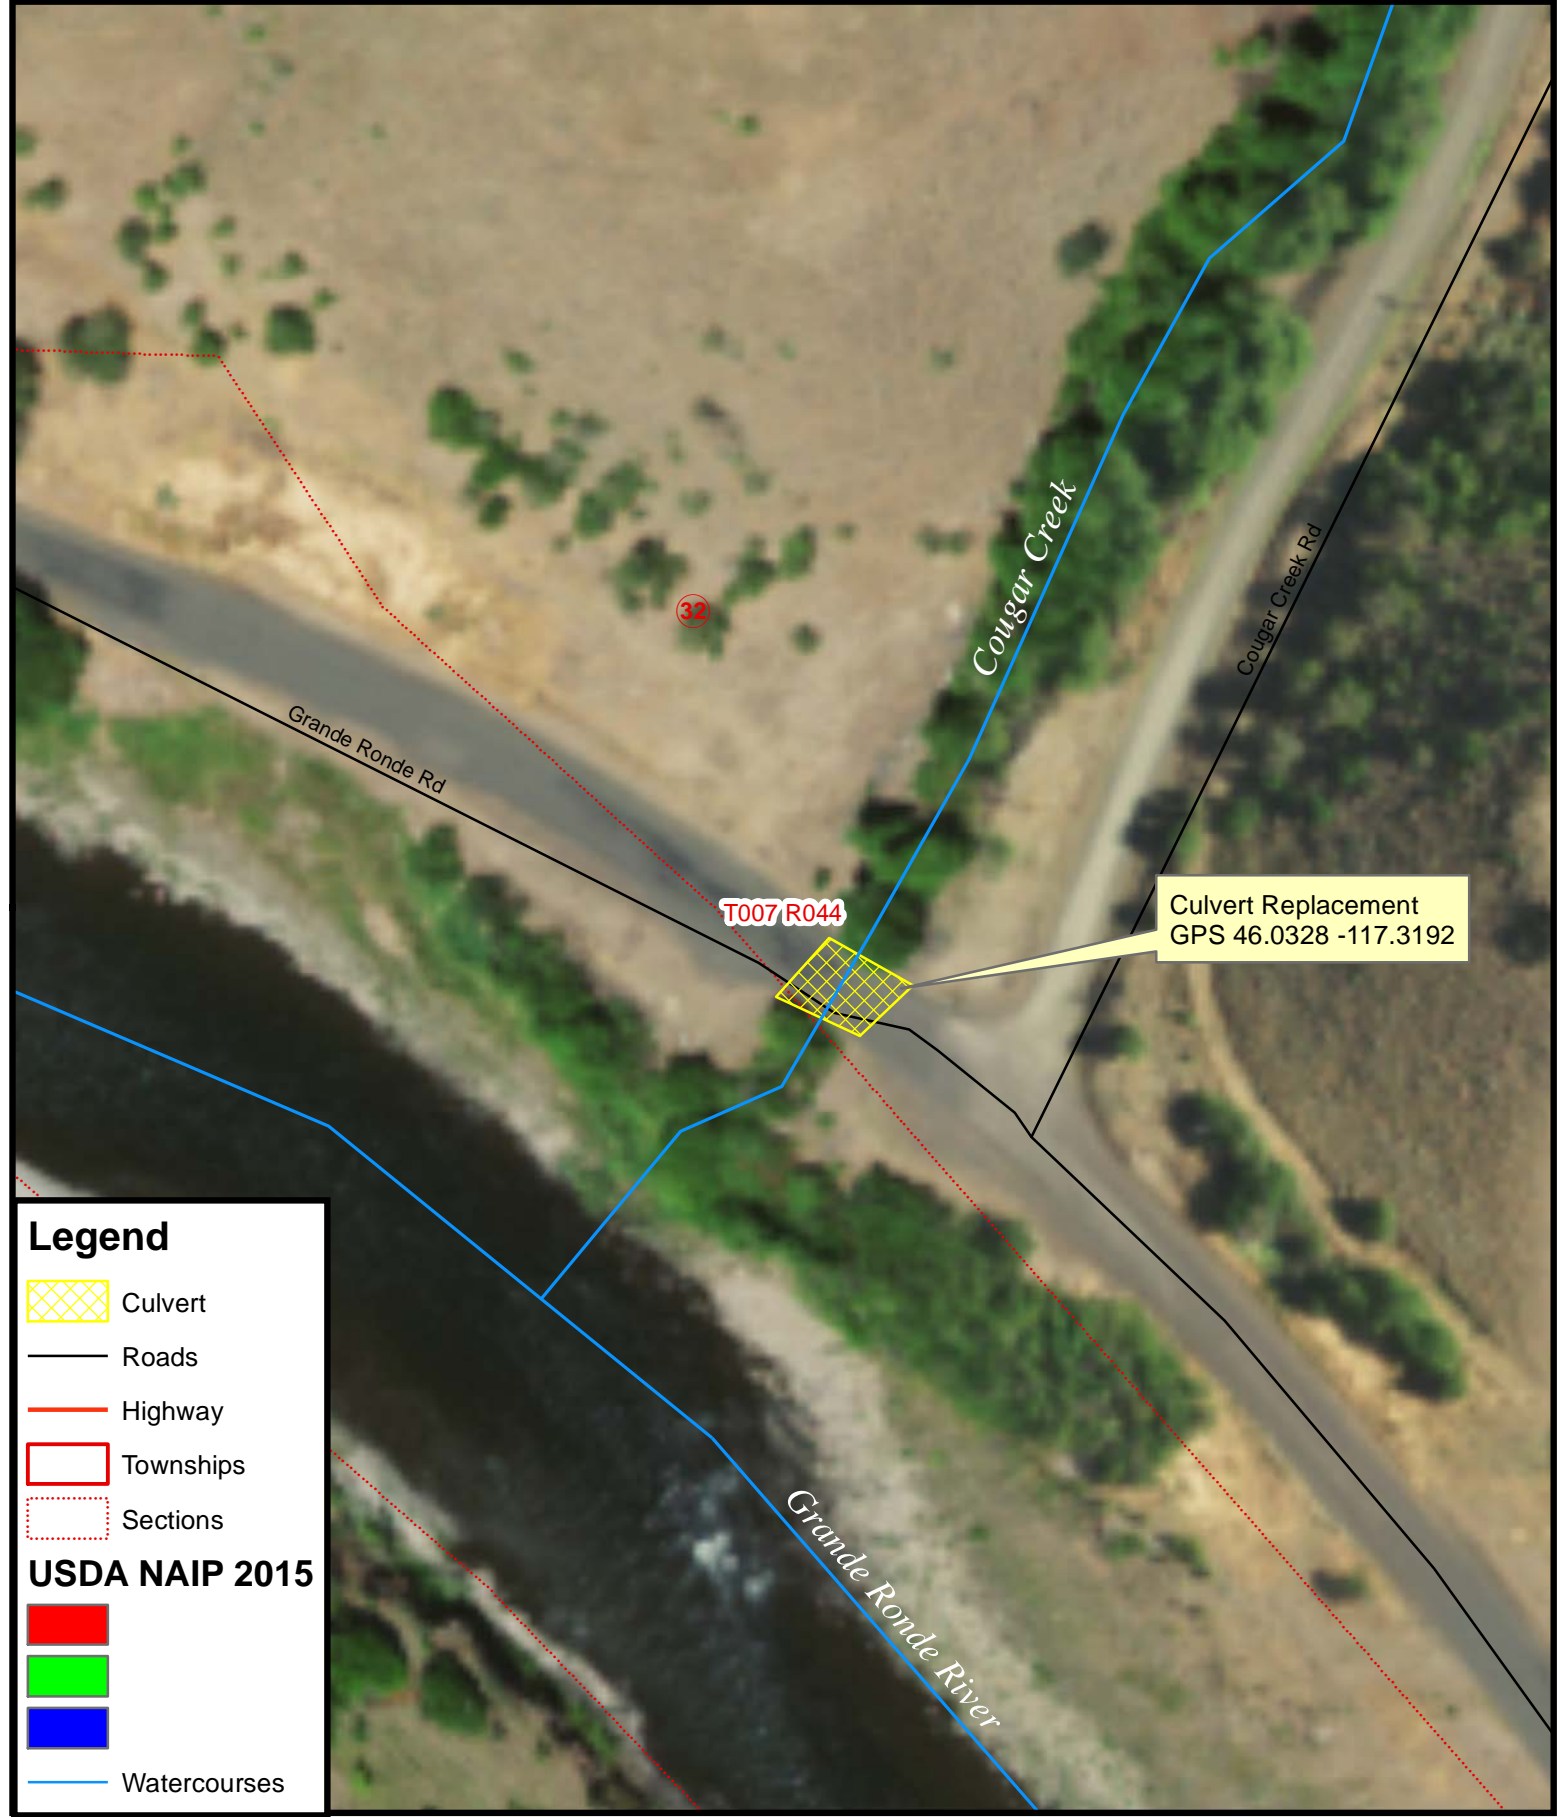
Cougar Creek Culvert Replacement APE

Cougar Creek

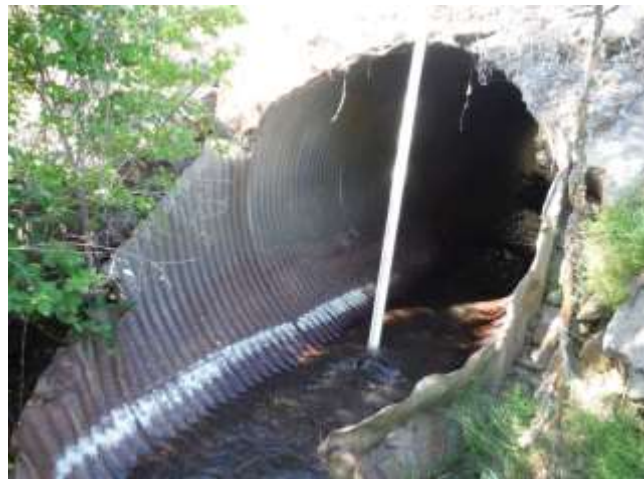
Culvert Details						Level A Parameters						
<u>ID</u>	<u>Shape</u>	<u>Material</u>	<u>Span</u>	<u>Rise</u>	<u>Length</u>	<u>WDIC</u>	<u>Apron</u>	<u>WSDrop</u>	<u>Location</u>	<u>Countersunk</u>	<u>Backwater</u>	<u>Slope (%)</u>
1.1	RND	CST	1.79	1.88	14.00	0.08	NO	0.27	Outlet	No	No	3.07

Channel Description	
Toe Width (m):	<input type="text"/>
Average Width (m):	<input type="text" value="5.81"/>
Culvert/Stream Width Ratio:	<input type="text" value="0.31"/>
Plunge Pool	
Length (m):	<input type="text" value="4.20"/>
Max Depth (m):	<input type="text" value="0.57"/>
OHW Width (m):	<input type="text" value="4.20"/>
Road	
Fill Depth (m):	<input type="text" value="2.50"/>

Assessment Results			
Barrier:	<input type="text" value="Yes"/>	Passability (%):	<input type="text" value="33"/>
Reason:	<input type="text" value="Slope"/>	Fishway Present:	<input type="text" value="No"/>
Method:	<input type="text" value="Level A"/>		
Recheck:	<input type="text"/>

Comments
Slope and W.S. Drop barrier. Culvert is damaged at the outlet.

This project will be designed to ensure fish passage during all stream flow levels. Currently the culvert outlet is perched causing a fish passage barrier, especially for juvenile fish trying to access cooler stream reaches.
