21-1005, Rest, Asotin Co Conservation Dist Cougar Creek Fish Passage Restoration, RCO Grant Request: \$200,000

The Asotin County Conservation District is sponsoring the restoration of the Cougar Creek culvert, which is a partial fish passage barrier where Cougar Creek flows under the Grande Ronde River Road. The barrier poses an imminent threat to anadromous fish (Steelhead) and limits their access to approximately 2.25 miles of rearing and spawning habitat upstream of the culvert. As stated in the Snake River Salmon Recovery Plan, Steelhead are especially effective at accessing and utilizing stream reaches with suitable habitat, however, their distribution is limited by environmental issues such as migration barriers. Cougar Creek flows directly into the Grande Ronde River approximately 140 feet below the barrier. The current culvert was identified in 2010 by the Walla Walla Community College Road Crossing Barrier Assessment as a barrier. ACCD is utilizing funds received a 2020 SRFB grant and BPA to complete the design for the project. The culvert is located where Cougar Creek flows under the Grande Ronde River Road approximately 4.5 miles west of highway 129. The project lies wi

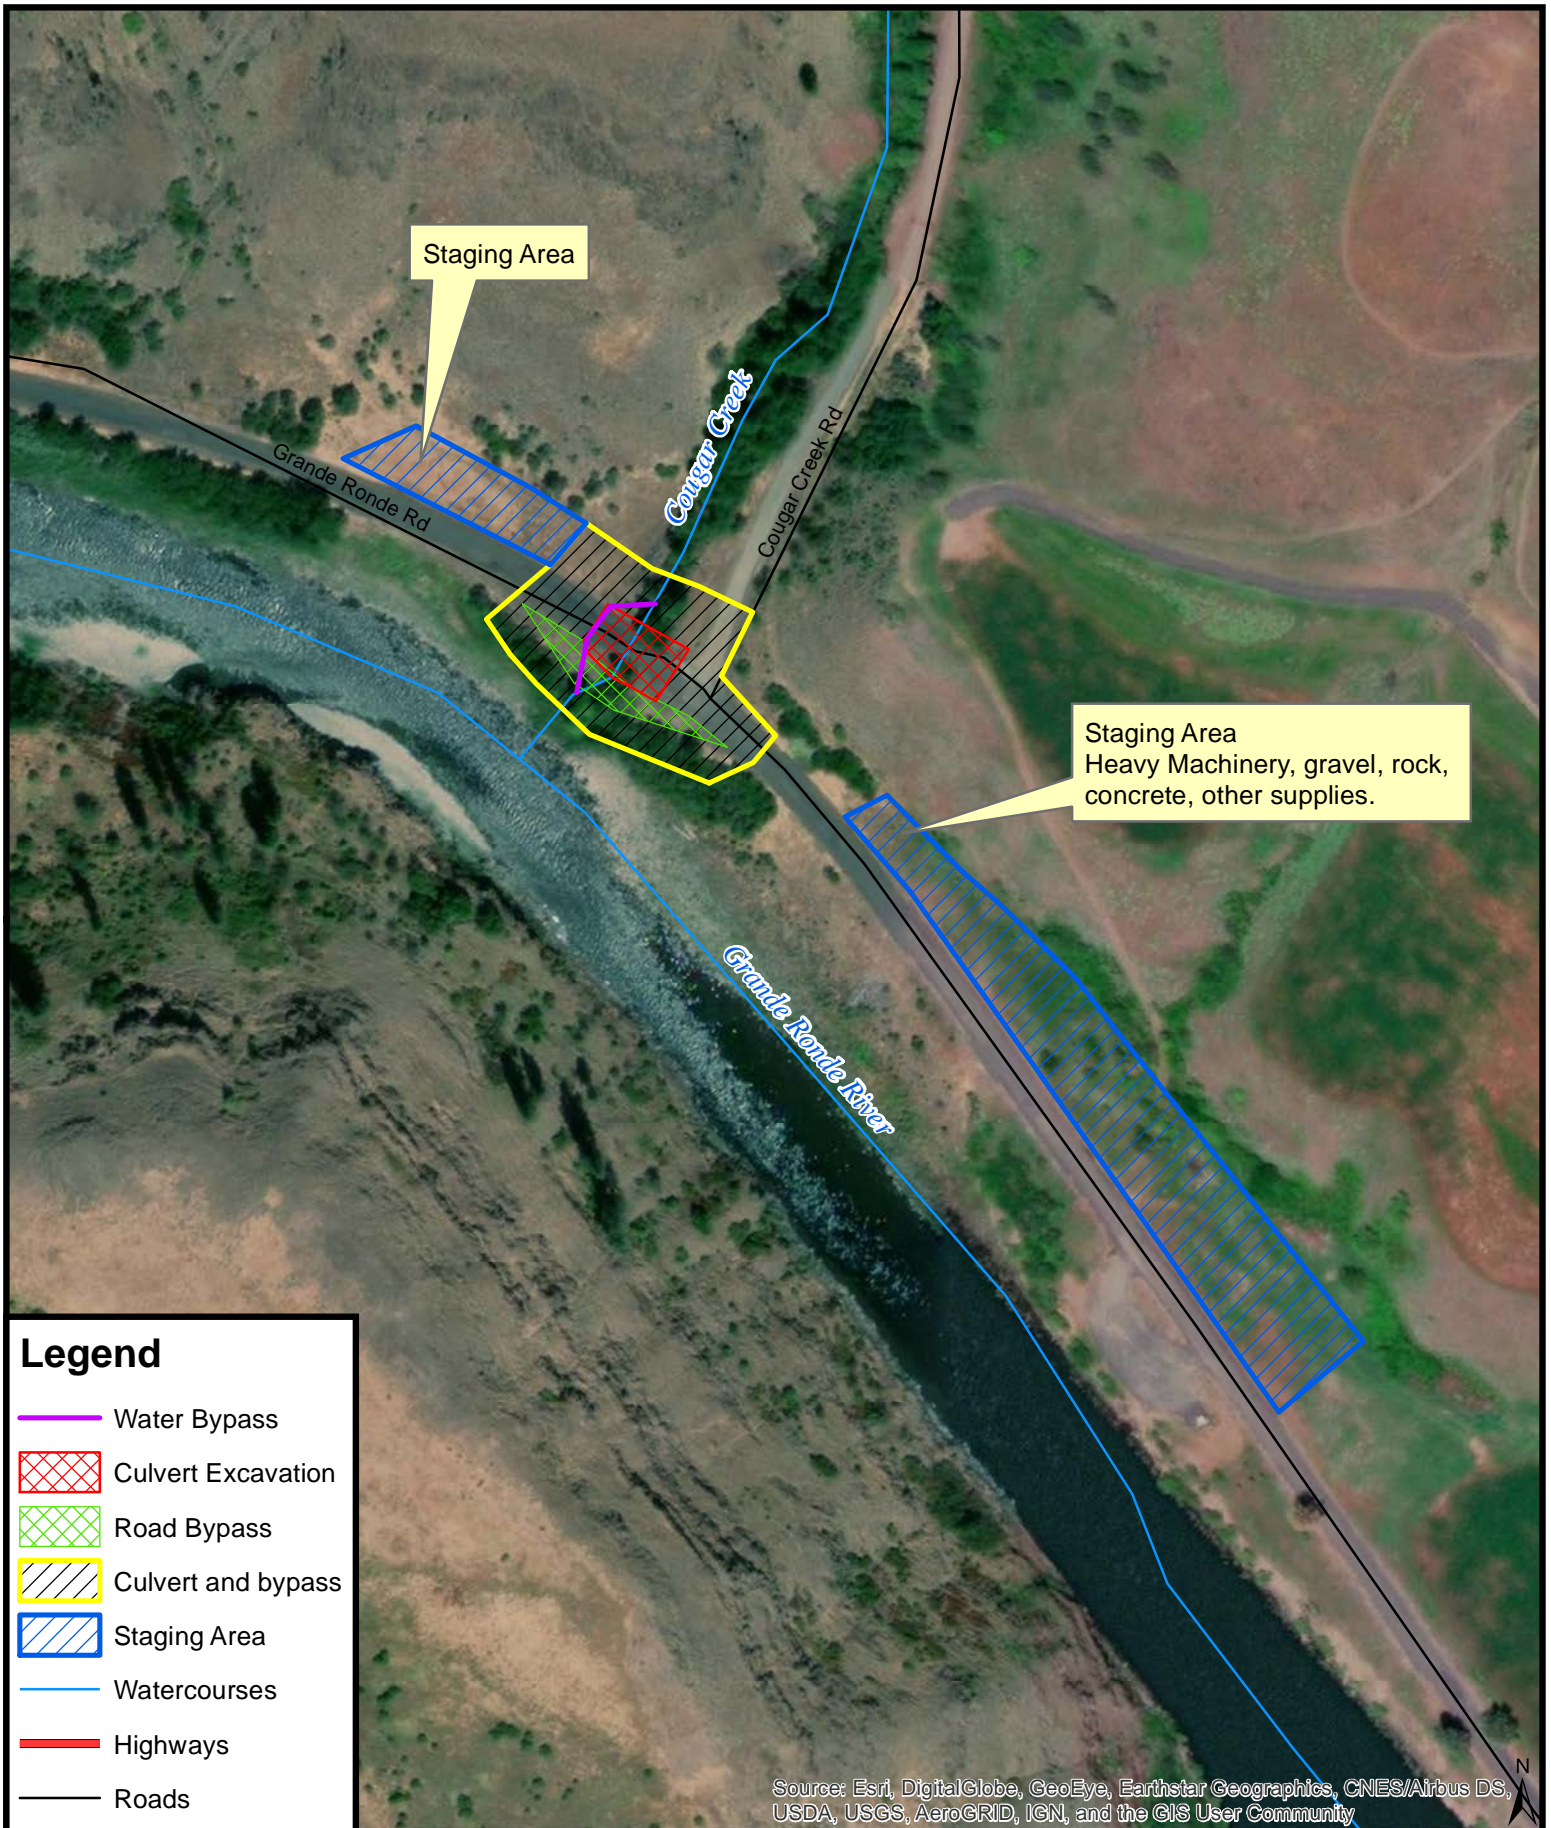
Cougar Creek Culvert Replacement

Staging Area

Staging Area
Heavy Machinery, gravel, rock, concrete, other supplies.

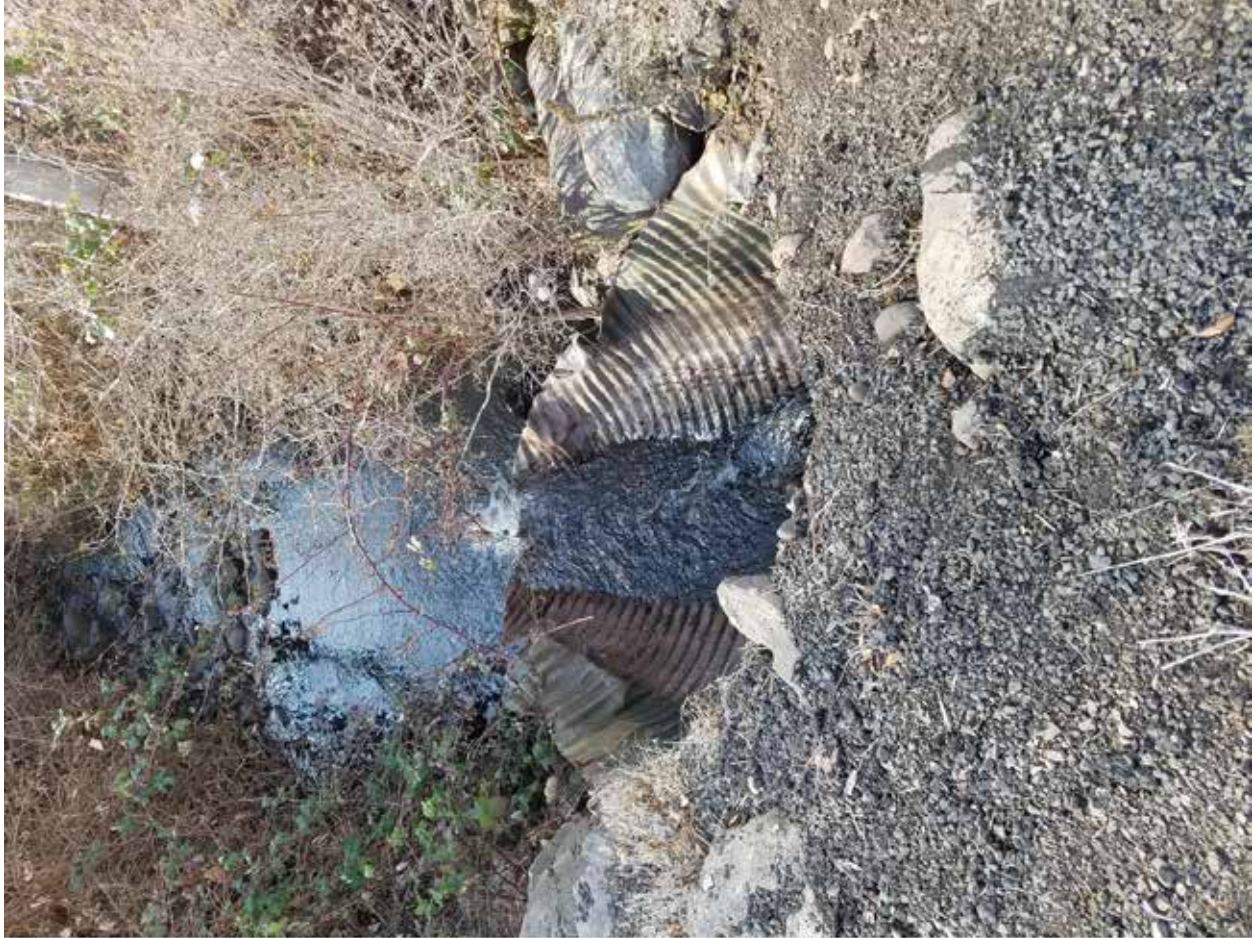
Attachment#462208_Cougar Creek Photo - Outlet View from Road.jpg

Corrugated culvert that is more than 40 years old. Round with a 6 foot diameter. Damaged on the bottom of the outlet side and perched. Approx. 40 feet in length at the bottom and 30 feet at the top. Approx 3 to 4 feet of fill and paved road.

during all stream flow levels. Currently the culvert outlet is perched causing a fish passage barrier, especially for juvenile fish trying to access cooler stream reaches.
