PROJECT: 22-1007 REST, COUSE CREEK PA 78 RESTORATION

Project Application Report - 22-1007

Worksite #1: Couse Creek - PA 78

Couse Creek
 Reach CO_01
 Project Area 78
 River Mile 0.1 to 0.7

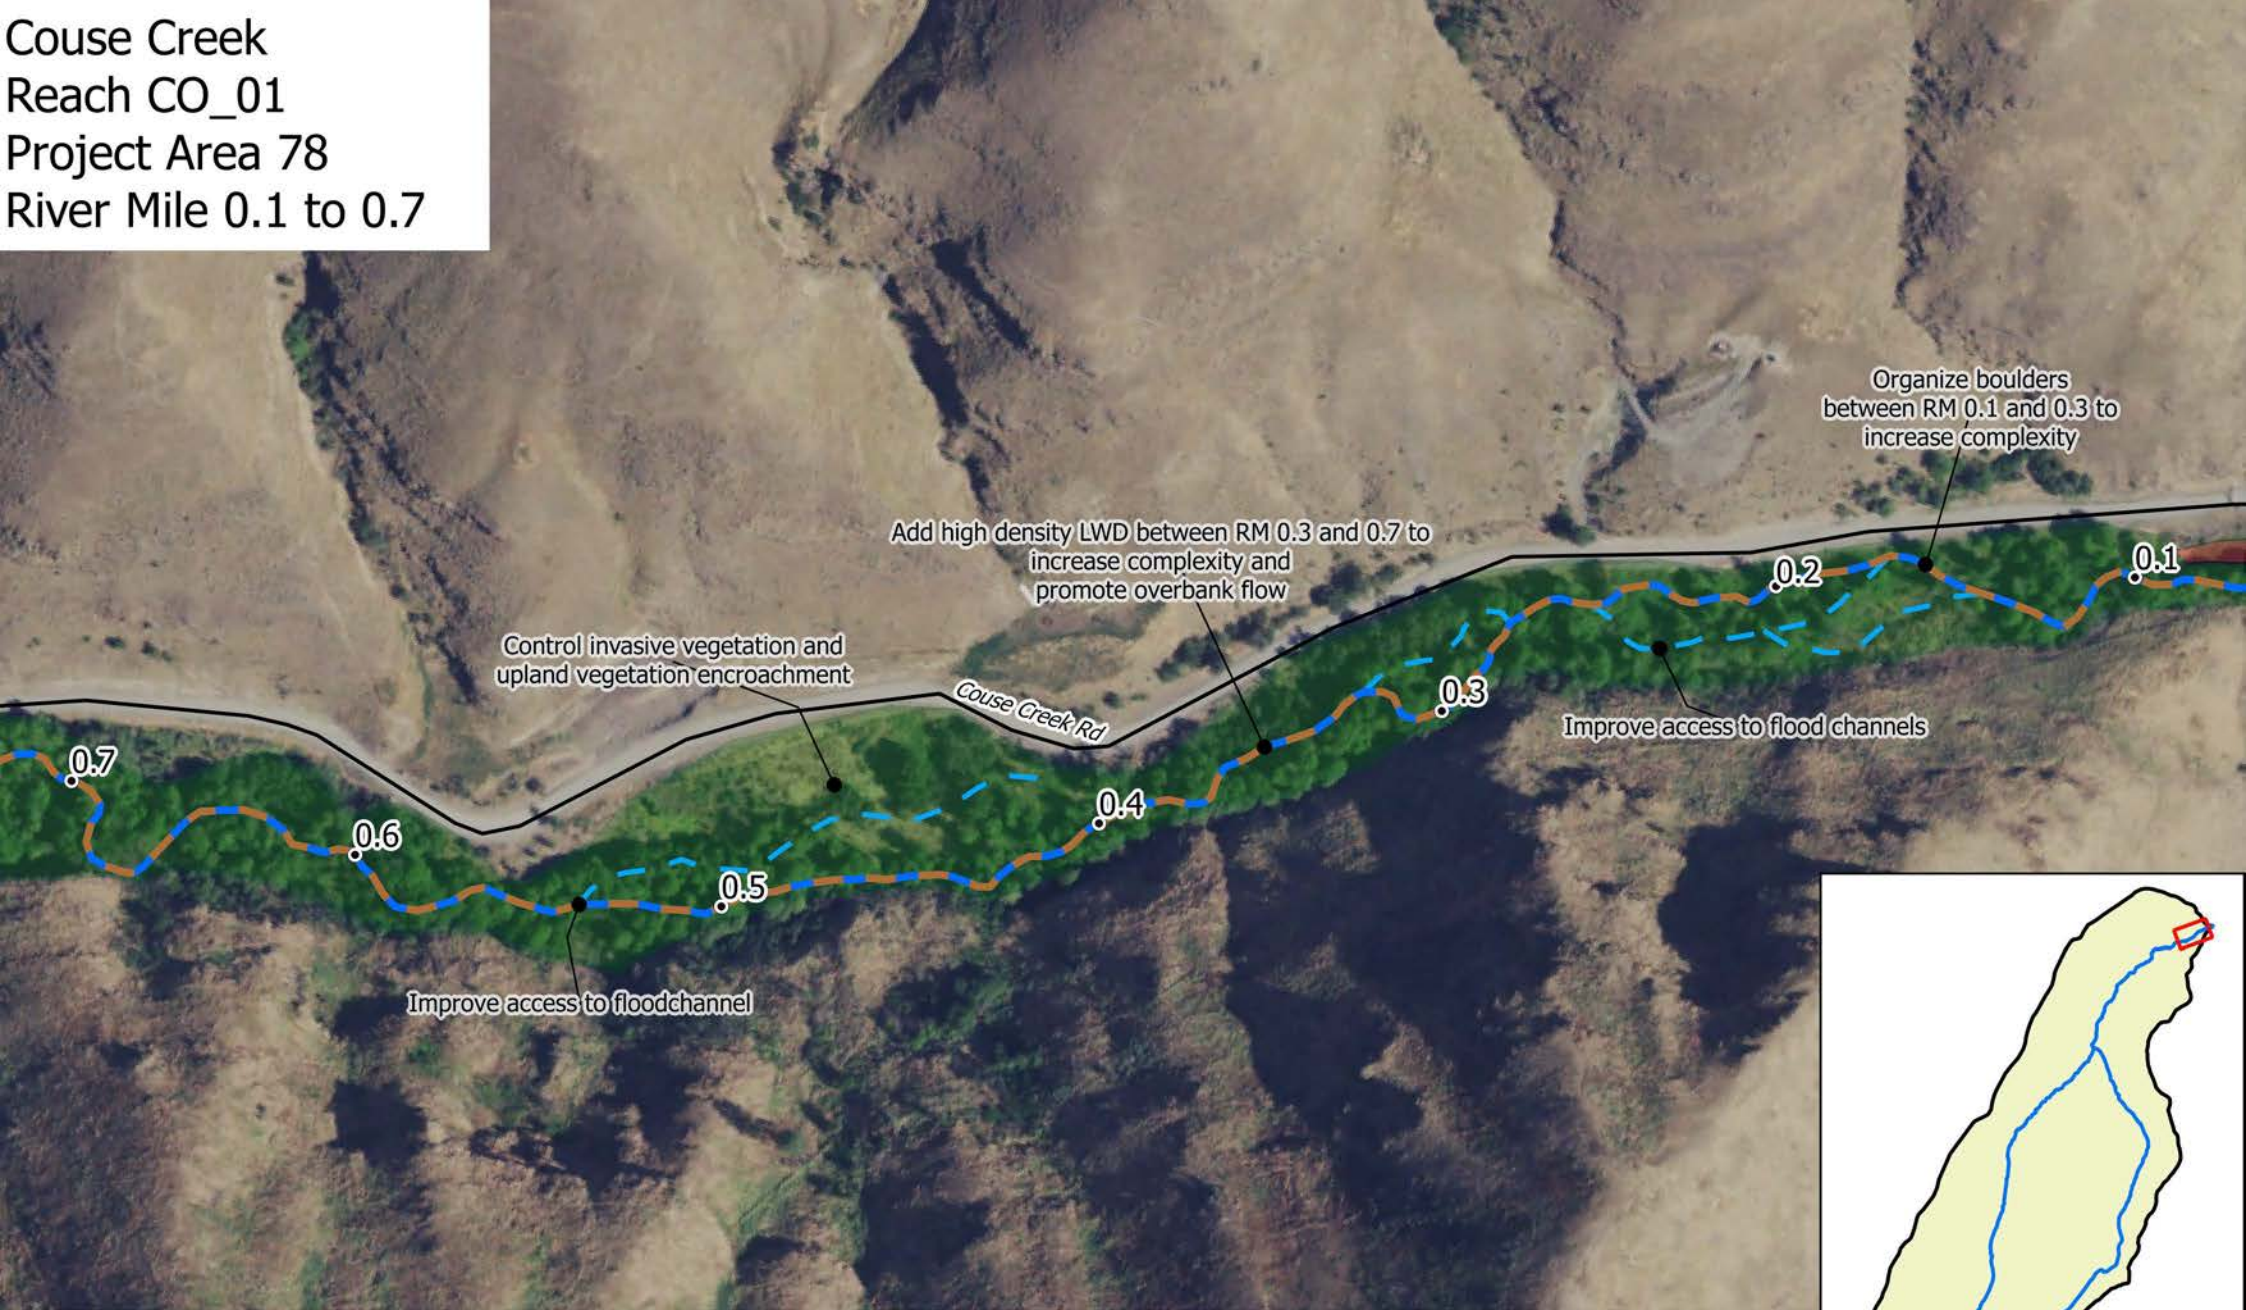
Organize boulders between RM 0.1 and 0.3 to increase complexity

Add high density LWD between RM 0.3 and 0.7 to increase complexity and promote overbank flow

Recommendations for PA-78 include improving access to flood channels, controlling invasive vegetation encroachment, organizing boulders into cluster or ribs between RM 0.1 and 0.3, and adding LWD PALS, ELJ and BDA structures to the channel and floodplain throughout. Improve access to flood channels and promote overbank flow.
