PROJECT: 22-1004 REST, STEPTOE CREEK PALS PHASE II

Sponsor: Palouse Conservation District Program: Salmon State Projects Status: Preapplication

2022 Snake River Salmon Recovery Board Project Application
Letter of Intent
Steptoe Creek Phase II PALS

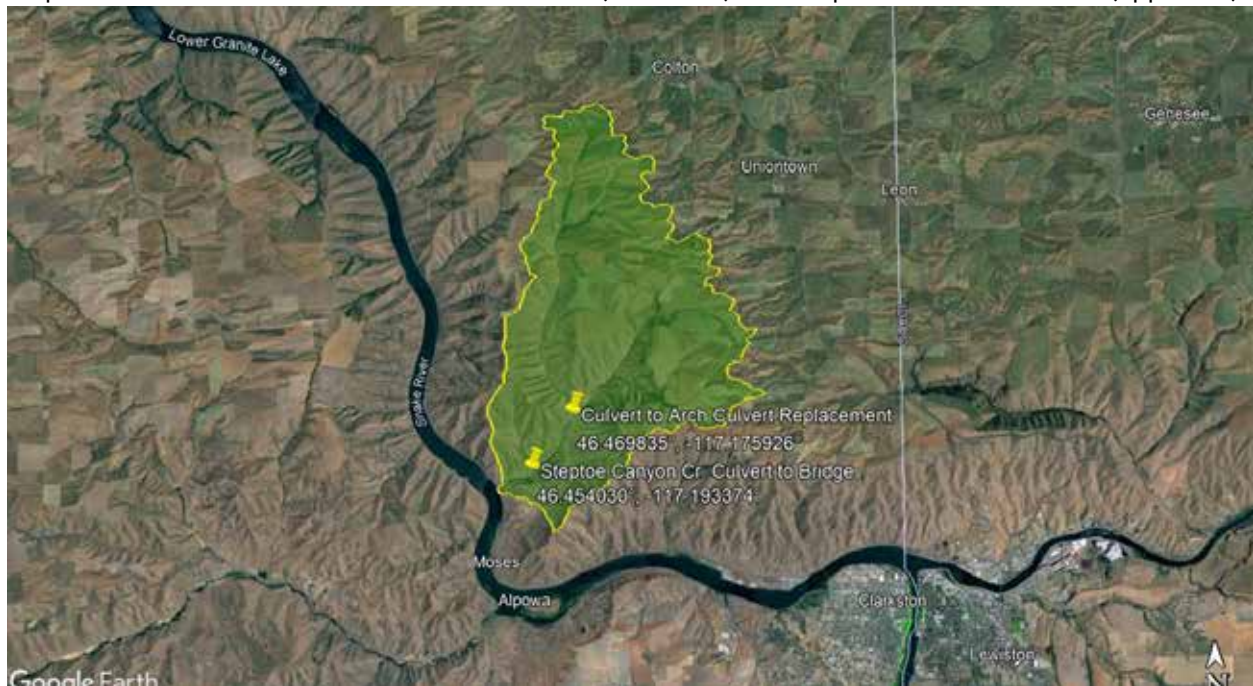
Steptoe Creek Watershed w/locations of BEFORE (Lower Pin) and Proposed Perched Culvert (upper Pin)

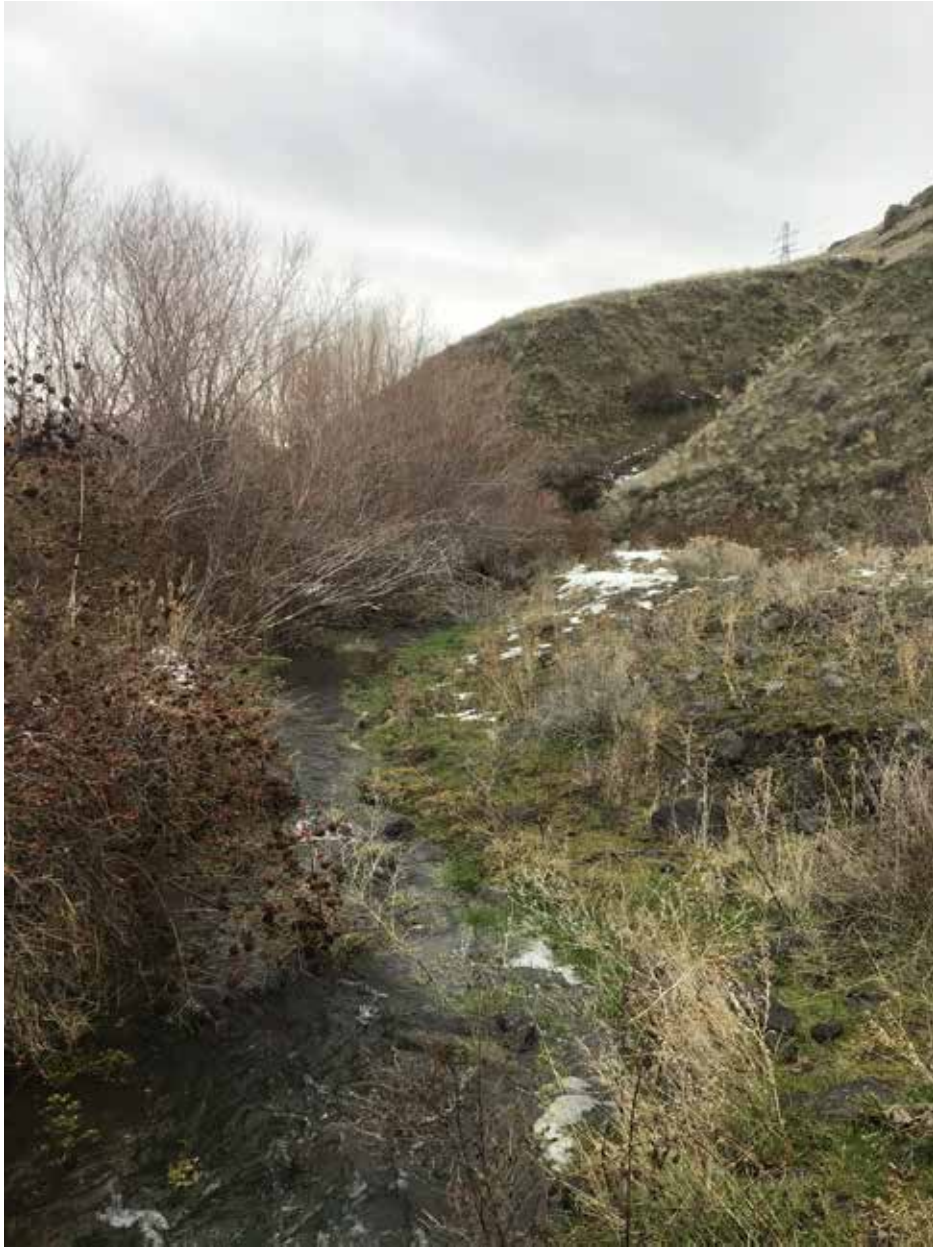
Step toe Creek Stream Area where Project is Proposed

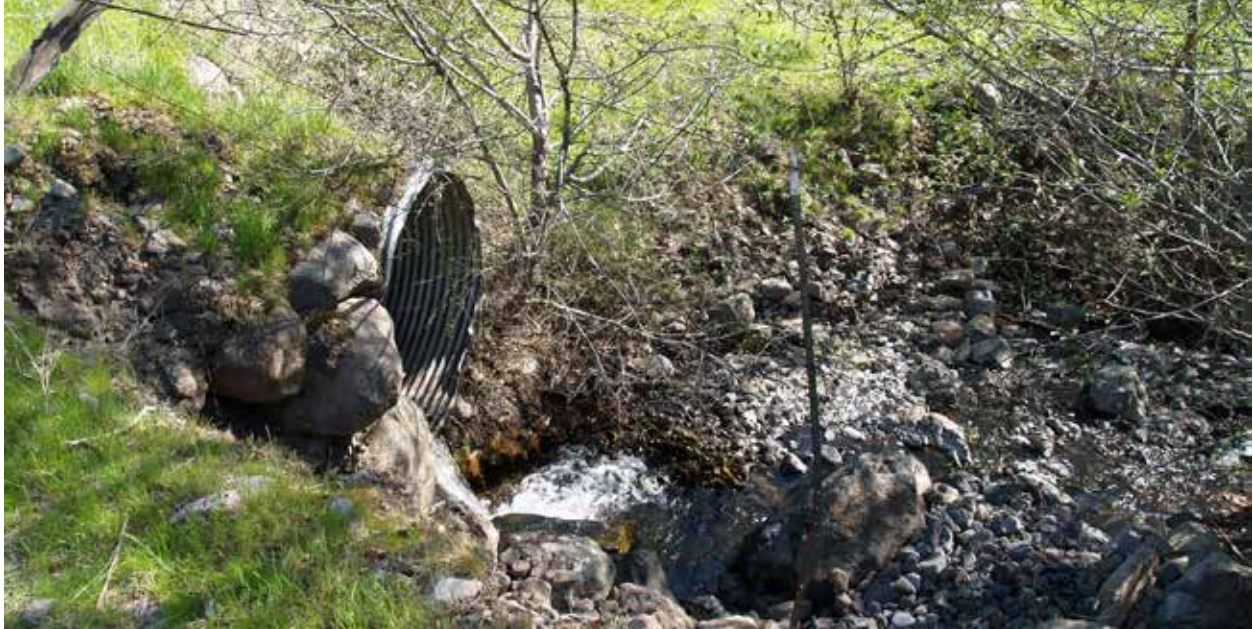
Steptoe Creek Watershed with location of Perched Culvert & eligible CREP below complete barrier

The Palouse Conservation District in cooperation with the landowner and Whitman County Road Department submitted an RCO Salmon Grant #14-1914 Steptoe Creek Perched Culvert Design & Assessment, this resulted in RCO #15-1309 Steptoe Creek Perched Culvert Replacement grant, which removed the complete barrier with a full span bridge in 2017. This opened up 4.8 miles on the mainstem of Steptoe Creek and an additional 3.1 miles on Stuart Creek, which is a cold water, spring fed tributary to Steptoe.

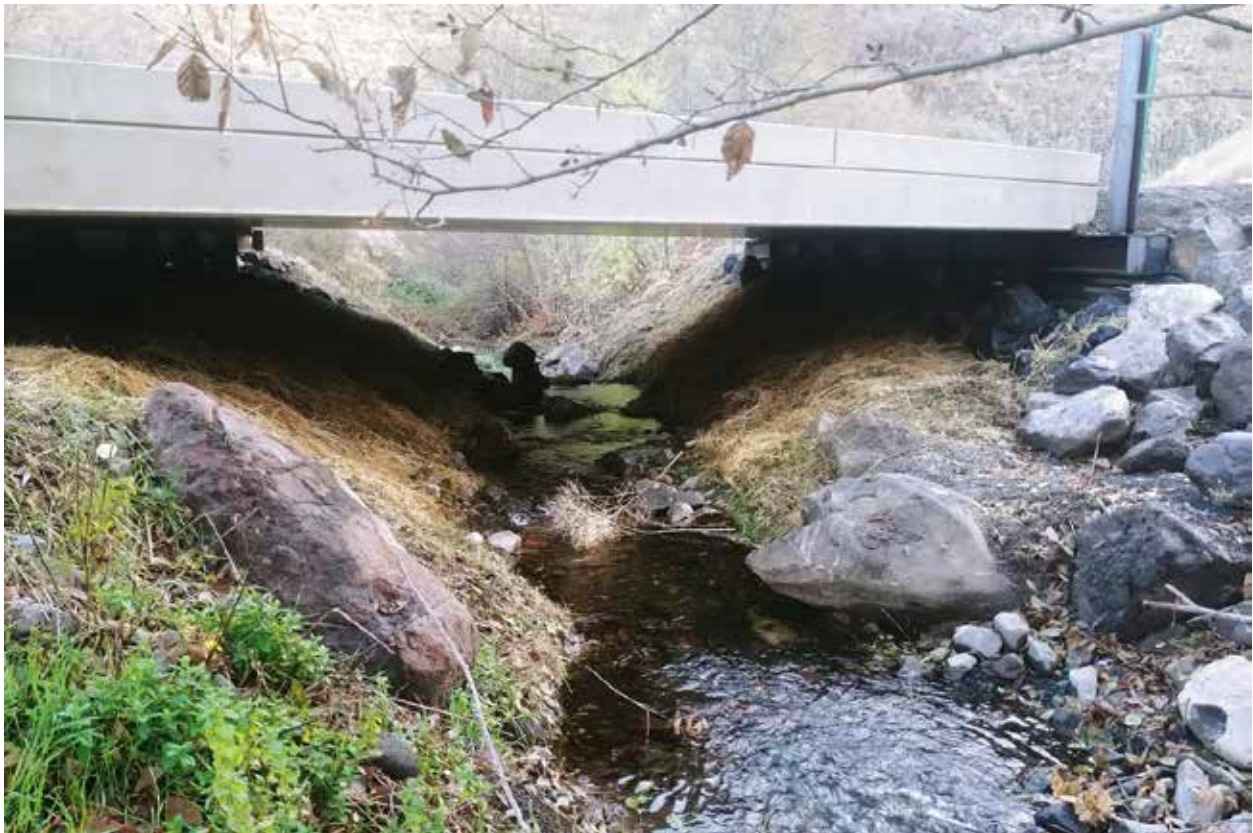
Outlet of Perched Culvert before Bridge Installation

New Bridge on Steptoe Creek replacing the Perched Culvert

RCO #15-1309 Steptoe Creek Perched Culvert Replacement Grant

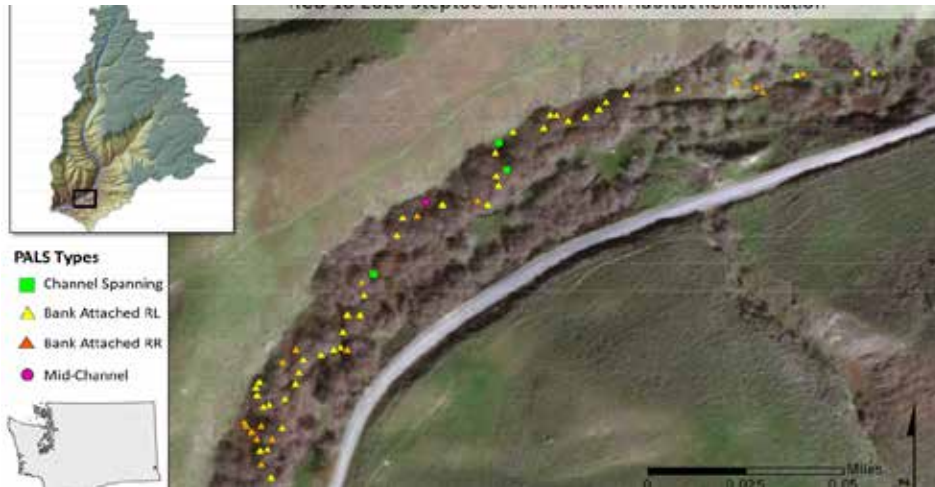
Downstream view of Bridge Replacement Project with steelhead passage barrier removed.

After barrier was removed, implemented RCO #18-2020 Steptoe Cr. Instream PALS Project above bridge.

<i>PALS Type</i>	<i>Count</i>
Channel Spanning	5
Bank Attached RL	47
Bank Attached RR	78
Mid-Channel	5
Total	135

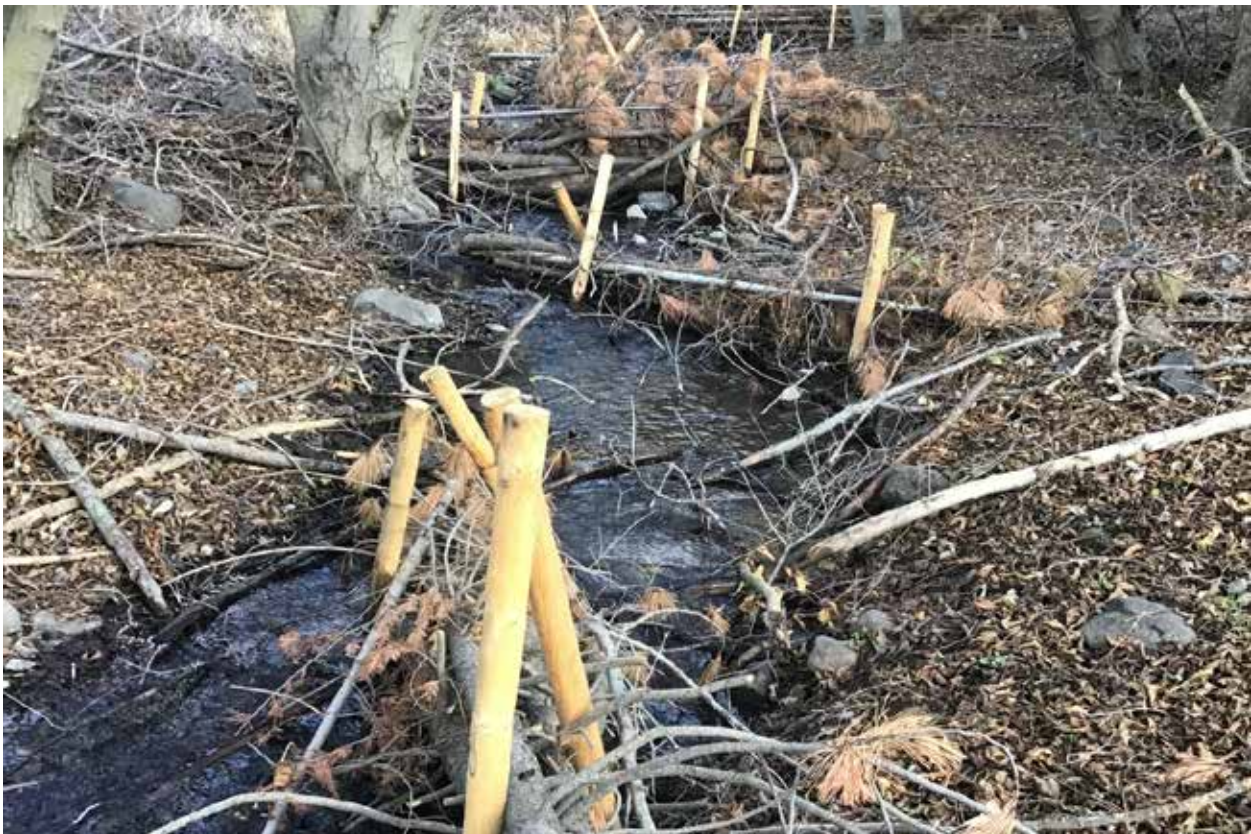
Example of 5 different PALS structures above the bridge. Bridge would be in bottom left of above photo
